MISCELLANEOUS PAPER CERC-86-2

GENERALIZED MONITORING OF SEASCAPE® INSTALLATION AT CAPE HATTERAS LIGHTHOUSE, NORTH CAROLINA

J. W. Forman

February 1986
Final Report

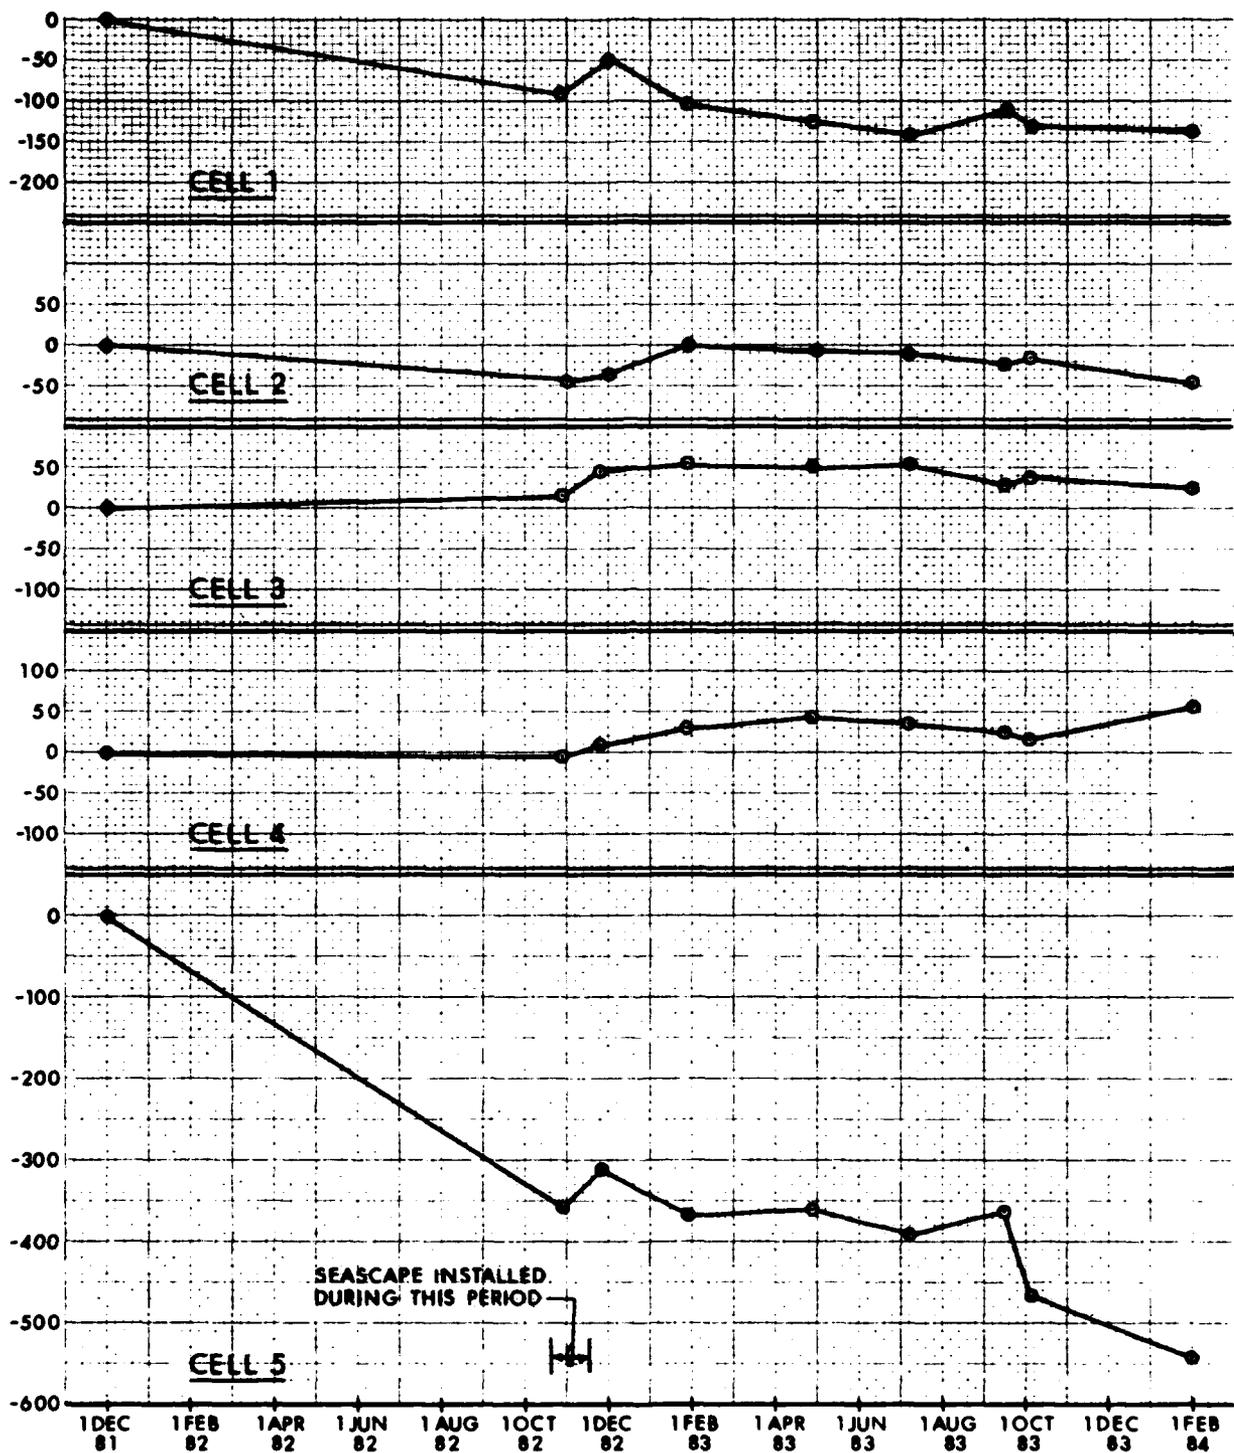
FIGURE 17

The plotted data in figure 17 reveals that, with the exception of the shoreline segments directly affected by the groin field, there is an overall trend of erosion in the study area over the period December 1981 to February 1984. The shoreline segments affected by the groins, cells 3 and 4, experienced a slight accretionary trend during the study period amounting to an average buildup of the shoreline of 25 to 60 feet, respectively.

During and immediately following the installation of SEASCAPE® in October and November 1982, an accretionary trend is apparent over the entire study area. The result is an average buildup of the beach in the study area of 25 feet. Close examination of figures 8 through 13 (Oct 82 through Jul 83) shows a progressive buildup in the southerly direction of the shoreline immediately south of the south groin. This is accompanied by general filling of the shoreline segment between and immediately north of the groins. However, during the accretionary period in cells 2, 3, and 4, the shoreline not directly affected by the groins, cells 1 and 5, experienced a period of fairly rapid erosion amounting to an average shoreline retreat of 80 feet.

AVERAGE SHORELINE POSITIONS IN EACH STUDY AREA CELL, DECEMBER 1981 TO FEBRUARY 1984 (FROM AERIAL PHOTOGRAPHS)

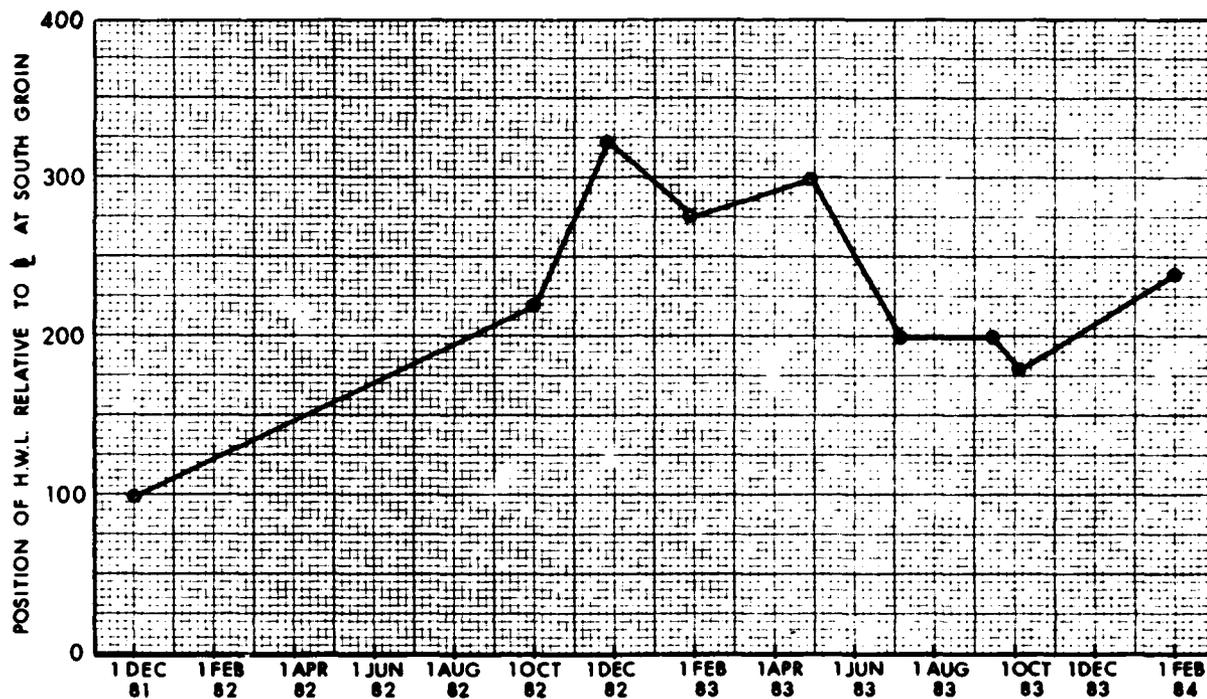
FIGURE 18

Changes in the shoreline position immediately south of the south groin, the area of specific interest in this study, are plotted in figure 18. The position of the shoreline at the south side of the groin measured from the baseline is plotted for each aerial photo date. Comparison with the plots in figure 17 for cells 3 and 4 shows a direct correlation between buildup in the area south of the groin with accretion of the entire shoreline affected by the groin field. This favorable shoreline condition has generally existed throughout the history of the groin field and its attendant impacts on shoreline configuration, with the singular exception of the condition generated by the March 1980 storm which induced a rapid and major temporary retreat of the beach immediately adjacent to and south of the southernmost groin. The fact that the immediate shoreline reach south of the groin field is favorably affected by the groin structures can be attributed to several factors. First, the groin field site is along a section of shore which

SHORELINE POSITION SOUTH OF SOUTH GROIN
 AT CAPE HATTERAS DECEMBER 1981 TO FEBRUARY 1984
 (FROM AERIAL PHOTOGRAPHS)

experiences a large volume of littoral transport ranging in magnitude to 1.5 million cubic yards per year and moving predominantly from north to south. This high volume of sediment transport is very large by comparison to the entrapment capacity of the 3-groin structures comprising the existing field, particularly on considering that the outer sections of the groin have been significantly damaged over time and that considerable quantities of littoral sediments pass through the groin system in a southerly direction. Additionally, the inner portions of the groins, extending landward from the high water line are low relative to the subaerial beach profile. This has allowed for passage of sediment through the inner portions of the groin field. Transport through the groin field is evidenced by a continuous beach berm and foreshore slope from north to south through the groin field, and the general absence of the saw-tooth pattern of upcoast accretion and downcoast erosion adjacent to groins which characterizes high groin structures. In regard to the effects of the March 1980 storm, causes of the anomalous rapid retreat of the shore immediately south of and adjacent to the southern groin are indeterminant but, in all probability, those causes were associated with the particular wave characteristics and wave direction generated by the storm. In any case, the storm also further damaged the outer portion of the southern groin and left a substantial gap between the inner and outer sections of the south groin structure. This structural gap serves as an excellent passageway for littoral sediments moving southward from the center - south groin compartment to the shore immediately south thereof. In return, the remaining outer section of the southern groin acts to diffract the predominant waves from the north to east ocean sector, resulting in a localized wave pattern which serves to accumulate sediments south of and adjacent to the southern groin.

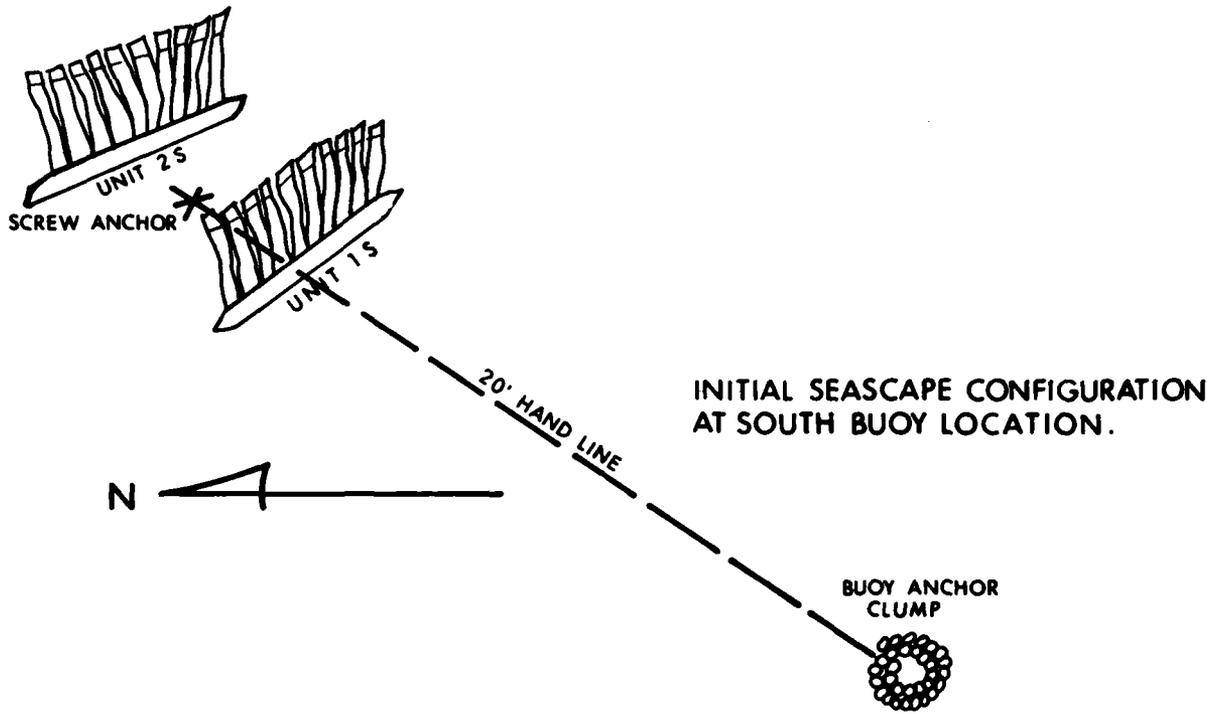
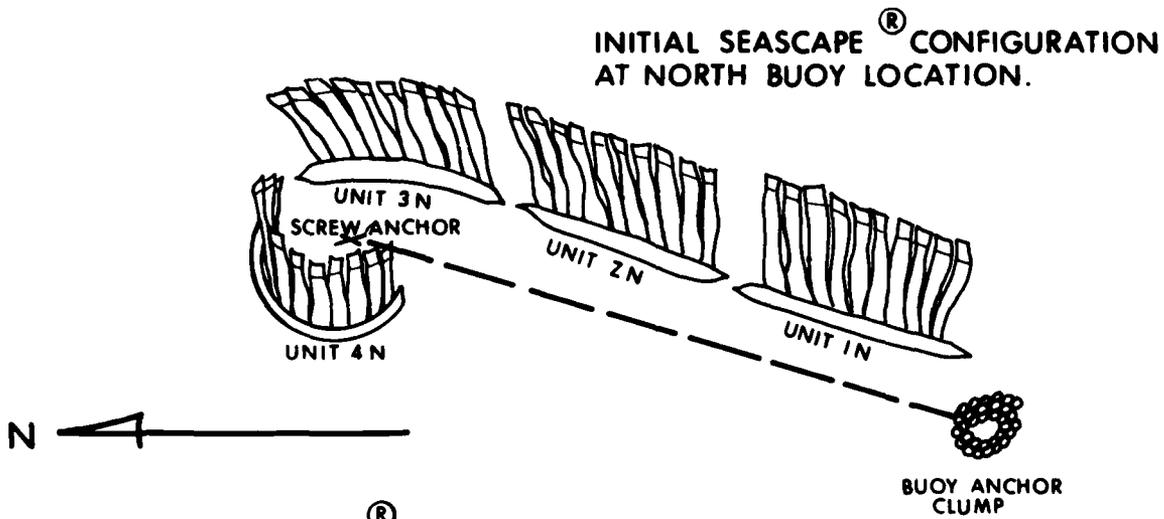
FIGURE 26

[®]
SEASCAPE CONFIGURATIONS AT NORTH AND SOUTH BUOY LOCATIONS

North Buoy Observations: Due to zero visibility on the bottom, a visual inspection of the area was impossible. However, divers did conduct a "hands on the bottom" search and were able to discover evidence of only one SEASCAPE® unit. Four 4-inch sections of fronds were exposed west of the screw anchor which would indicate that they belonged to unit 4N (see figure 26) identified during the first monitoring dive. None of the ping-pong size subsurface buoys identifying individual units or evidence of the other three units were found. The 2.05 feet of the screw anchor was exposed indicating that there had been an accumulation of sand at the anchor of 1.4 feet since the initial dive.

North Buoy Observation: The sand level was found to have accreted to within 0.20 foot at the top of the screw anchor shank indicating a 1.5-foot sand level rise since the November 30, 1982, installation. Fair visibility allowed a close inspection of the bottom, but no trace of SEASCAPE® units was found. One unit (marked by some floating line used by the contractor) was found approximately 30 feet east of the screw anchor. The tops of 3 fronds were exposed by digging down approximately 1 foot.
